Rio de las Vacas

Stream and Riparian Restoration Plan and Recommendations

**Santa Fe National Forest
Forest Service, Region 3**

**Gary Asbridge
Fish Biologist
Mt. Hood National Forest
Forest Service, Region 6**

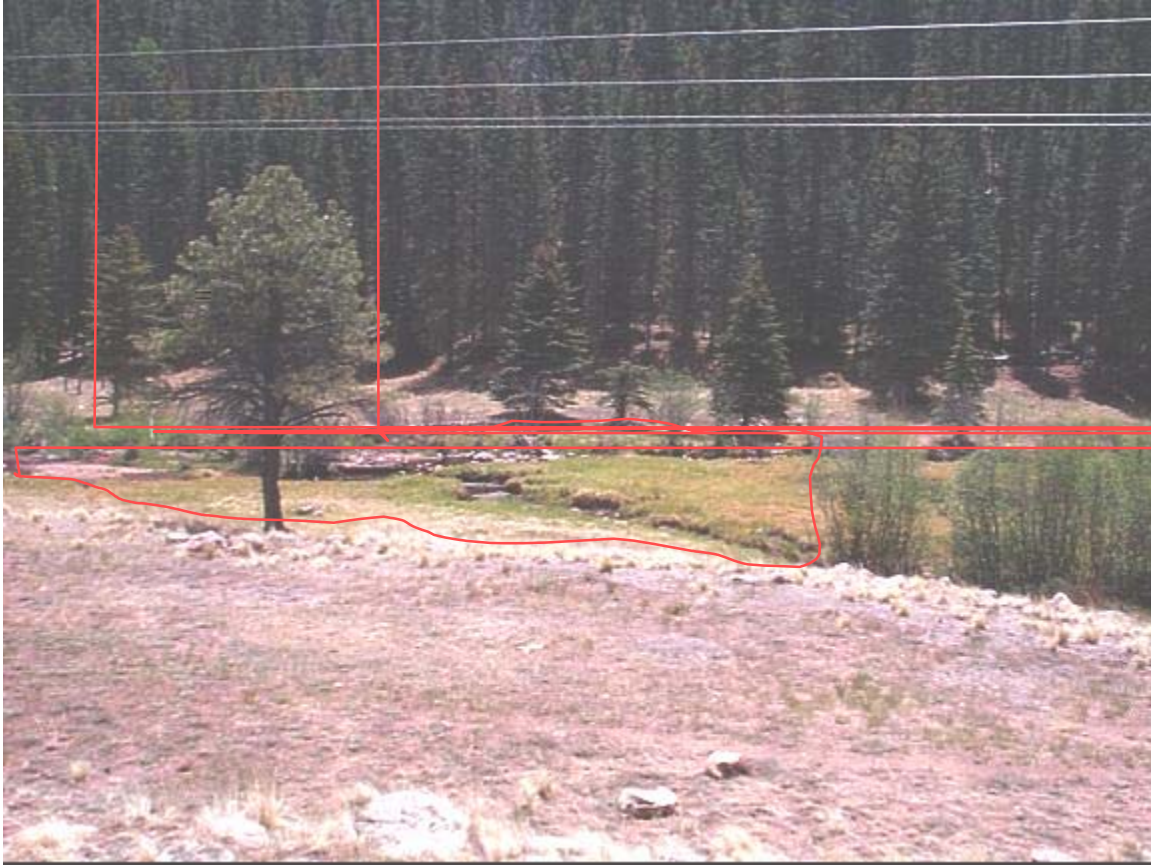
habitat, larger substrates, and very little woody riparian vegetation. It is unlikely this reach naturally had large amounts of LWD in the channel and flood prone area historically but the author believes LWD was likely present (more than now certainly), either routed from upstream reaches or from the occasional conifers or cottonwoods falling into or near the channel. In some areas in Reach 6 the channel was actually quite close to forested hill slopes and it is quite probable that trees fell into or along the channel with some regularity. Pines were also relatively abundant on the old terrace (Figure 3).
